Research Report 1434

**Human Factors Assessment:
Light Armored Vehicle,
Maintenance/Recovery Vehicle (LAVM/RV)**

**ARI Field Unit at Fort Hood, Texas
Systems Research Laboratory**

December 1986

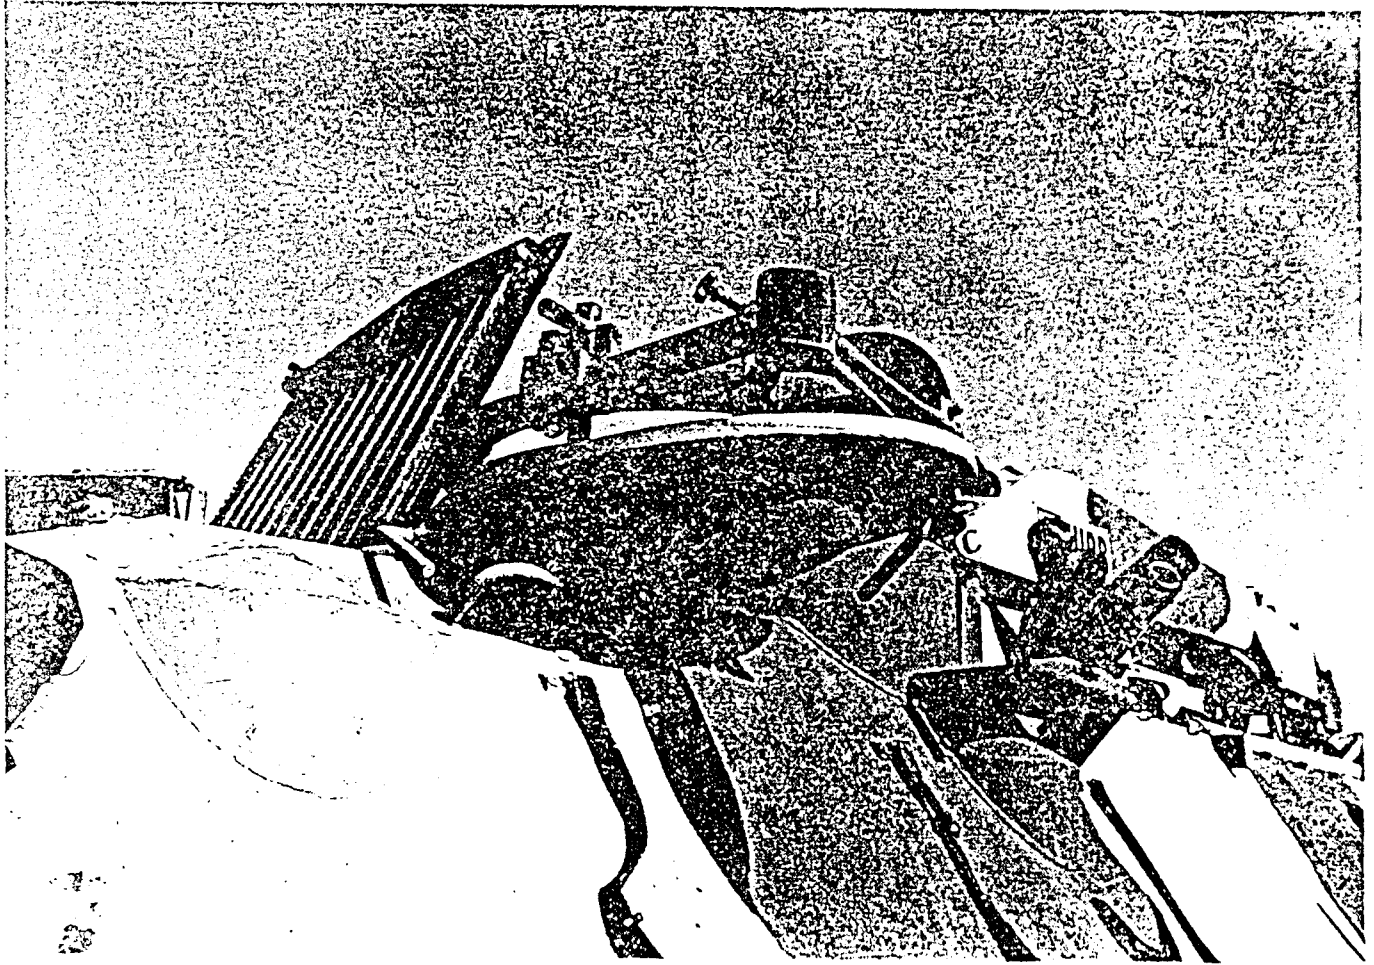
Figure 5. The M60 gun mount (above the open hatch) blocks the opening or closing of the driver's hatch.

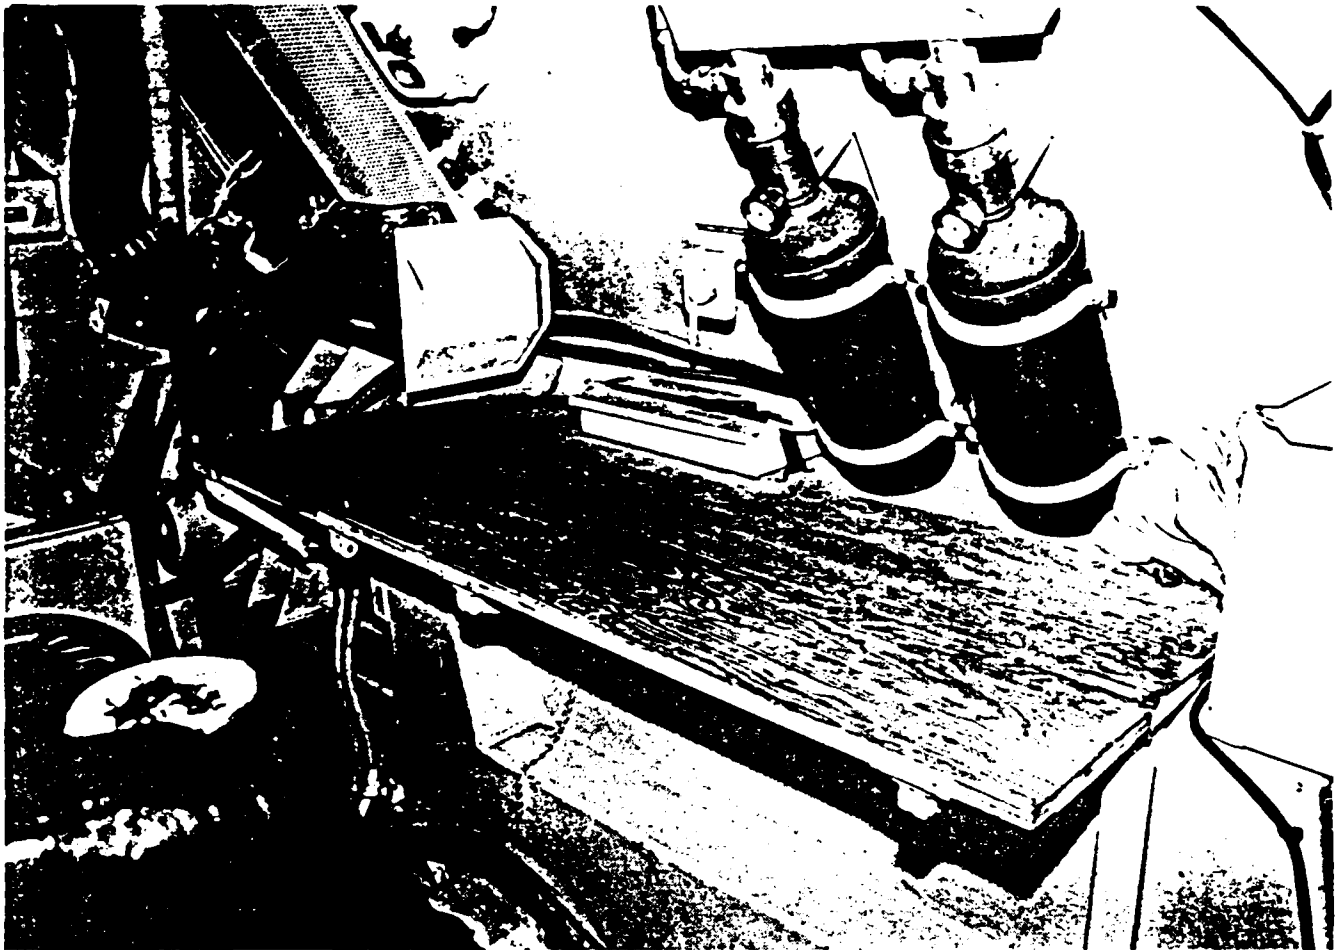
30.	Using workbench.	M = 3.0 Borderline	Workbench likely to be unused.
31.	Workbench features: Space for work Armroom when seated Legroom when seated Seating Ventilation Storage for tools Overall comfort	M = 2.7 Borderline M = 3.3 Borderline M = 2.1 Inadequate M = 2.5 Inadequate M = 3.4 Borderline M = 3.3 Borderline M = 2.5 Inadequate	Workbench likely to be unused. Crew discomfort may reduce time spent at workbench. Discomfort make make errors likely.

Figure 16. The workbench.
